# Example independent timber survey

# Timber Condition Survey Final Report

20 November 2025

| Instruction | Assess the condition and structural integrity of timbers in loft area of property |

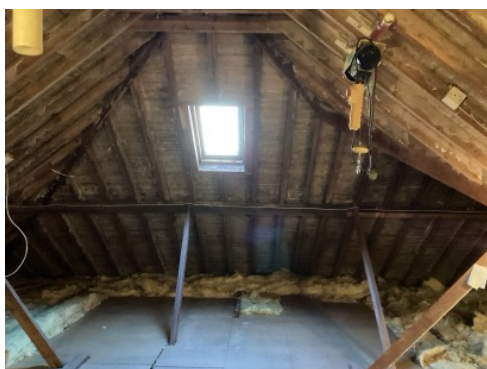
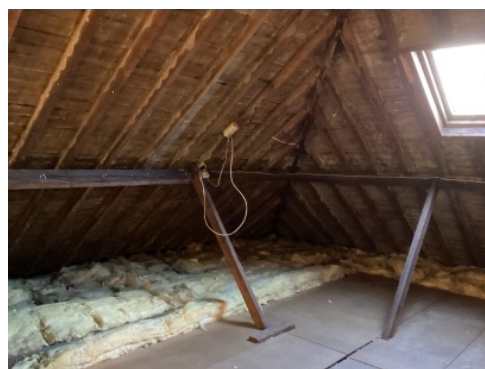
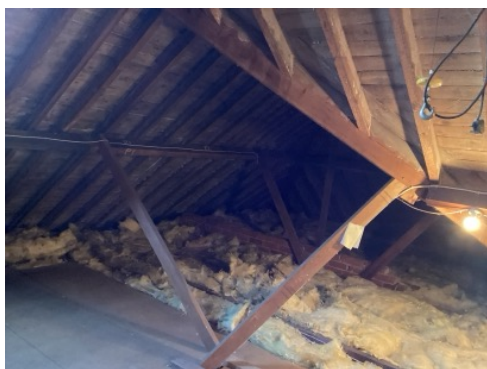
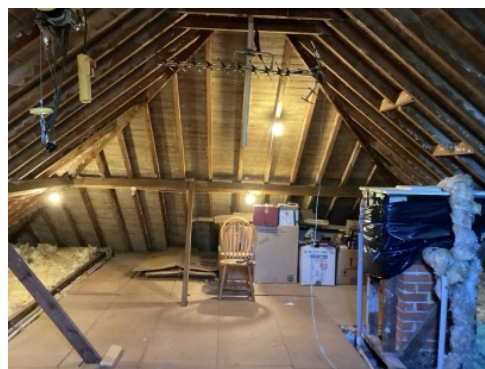
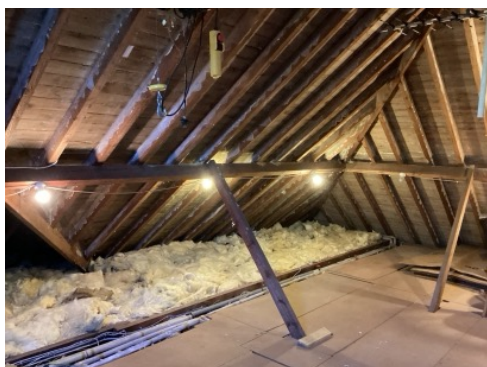
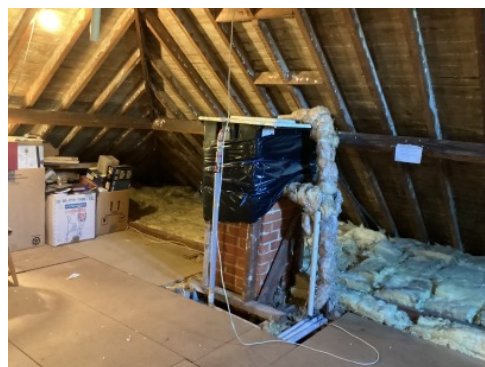
### Timber Condition Assessment

During the inspection, it was observed that the roof had been constructed using an older, traditional method in which timber lath boards were employed as the primary underlay beneath the roof covering. These laths predate modern breathable membranes and typically provide limited moisture control, relying heavily on adequate ventilation within the loft space. Their presence indicates that the roof structure likely predates contemporary building standards and may have been vulnerable to moisture retention an issue often exacerbated when spray foam is applied directly onto the underside of the roof covering.

A series of moisture tests was carried out on representative timbers throughout the roof, including rafters, purlins, ridge components, and the lath boards themselves. The results indicated significantly elevated moisture levels within the lath boards, with readings reaching up to 58%. Moisture content in timber above approximately 20-25% is considered conducive to fungal growth, and readings approaching 30% or higher reflect saturation levels where decay mechanisms may become active. Therefore, the recorded values, particularly the reading of 58.9%, represent a substantial moisture anomaly that requires attention.

Other individual timber members (rafters, purlins, etc) showed moderately raised moisture levels, suggestive of being on the threshold of a “wet” classification, although not yet fully damp or structurally compromised. The trimmers around the Velux window was also noted to be damped. These elevated readings may be attributable to historical moisture entrapment caused by the spray foam, which can restrict the natural drying capacity of the roof coverings by forming an impermeable barrier. Additionally, the underlying lath system, being inherently less breathable than modern membranes, may have further contributed to moisture accumulation.

1. It is recommended to improve loft ventilation to promote adequate airflow from eaves to ridge and support the drying of moisture-affected timbers. Allow the loft space to dry completely after removing the spray-foam insulation and completing any necessary repairs.

- 2.1 It is recommended to monitor the condition of the lath boards, particularly those with moisture readings as high as 58.9%, to verify whether the elevated levels decrease over time.

- 2.2 Assess the potential need to replace severely saturated laths with a modern breathable underlay system if high moisture content persists.
3. The twisted purlin marked P1 should be periodically monitored to confirm that the deformation is historical and that no progressive movement is occurring.

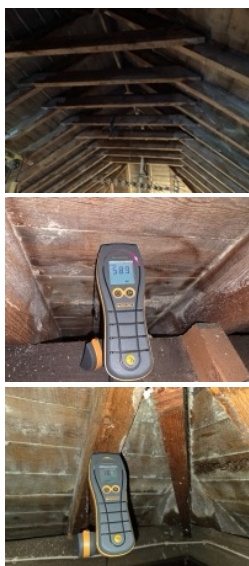
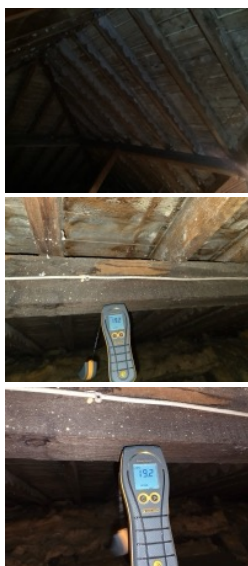
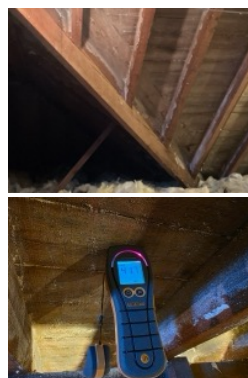
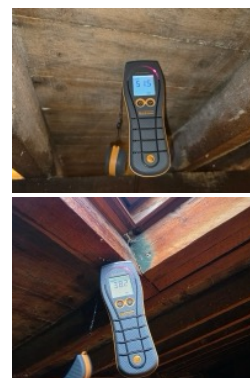
### Timber Condition Assessment Continued

Despite the elevated moisture readings, no immediate or widespread structural failure was observed at the time of inspection. However, localised areas of softening were identified within certain lath boards, consistent with prolonged exposure to high moisture levels. Similarly, surface discolouration and early-stage fungal staining were observed on some timber members, indicating conditions favourable to decay, although no advanced rot was detected. Lastly, the roof timbers generally retained their load-bearing form, but preventative measures are strongly advised to stop progression toward decay.

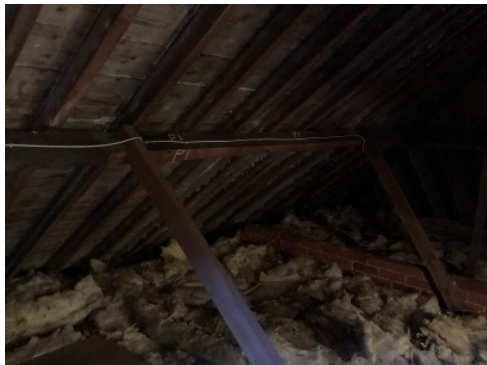
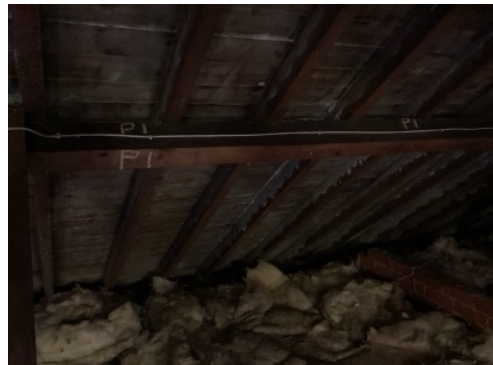
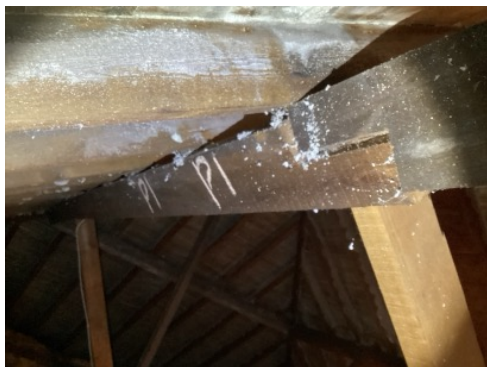
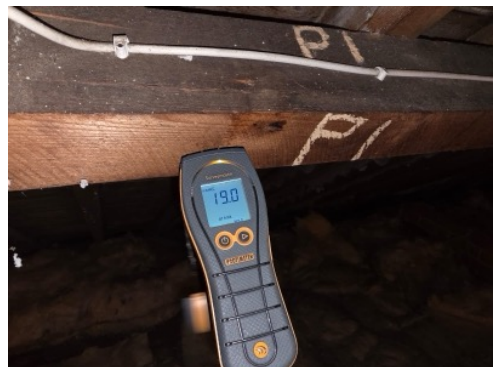
#### Timber P 1

19.0%

The purlin identified as P1 was observed to exhibit a degree of twisting along its longitudinal axis. The deformation appears to be historical rather than indicative of ongoing structural movement, as there were no signs of fresh cracking, timber distress, or associated distortion in adjoining structural members. However, due to the potential implications of purlin movement on roof stability, it is recommended that P1 be periodically monitored. Routine inspections will help to verify that the twisting is indeed historic and confirm that no progressive movement is occurring over time.

The observed movement should be monitored.

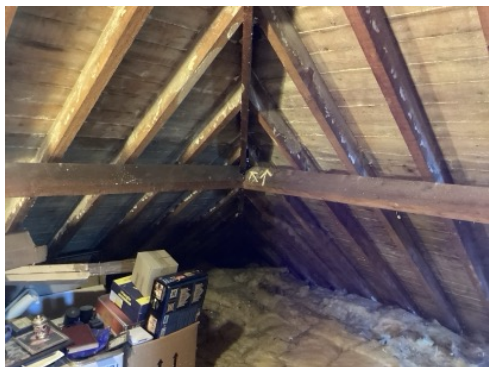
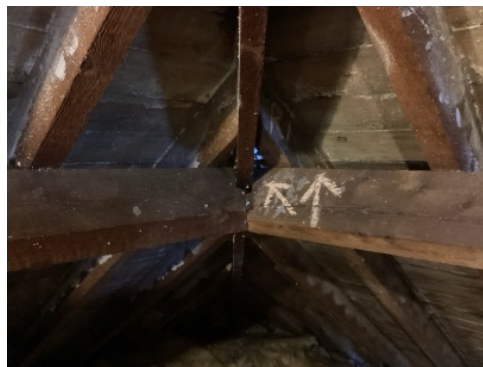
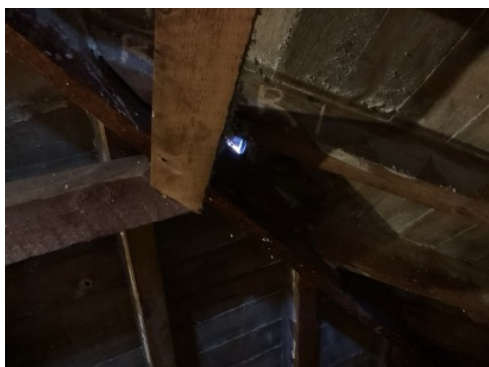
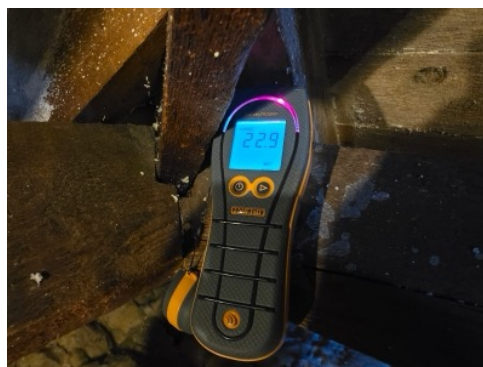
#### Timber R 1

22.9%

Was deterioration found? Yes

Deterioration depth (mm) 8

The rafter R1 showed elevated moisture due to a hole allowing water in. The moisture pattern indicates this localised ingress, not a roof system issue.

The timber member should be allowed to dry after the repairs

It's recommended to repair the hole quickly, then dry the loft naturally or with ventilation. Follow-up moisture readings should confirm proper drying and no secondary defects.

4. Repair the hole adjacent to rafter R1 to prevent further water penetration. After the repair is completed, allow the affected timber and the surrounding loft area to dry naturally or through assisted ventilation, followed by repeat moisture testing.

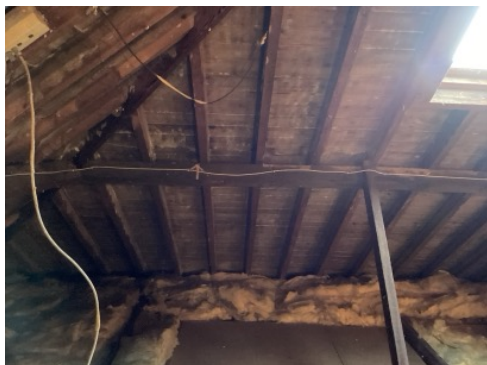
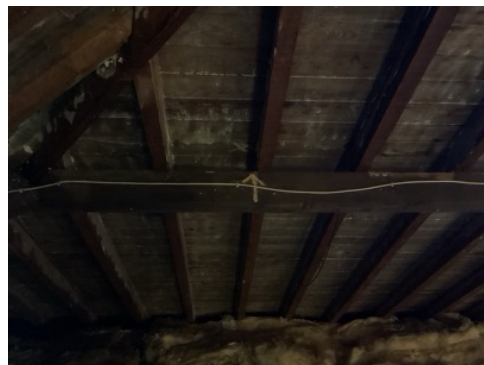
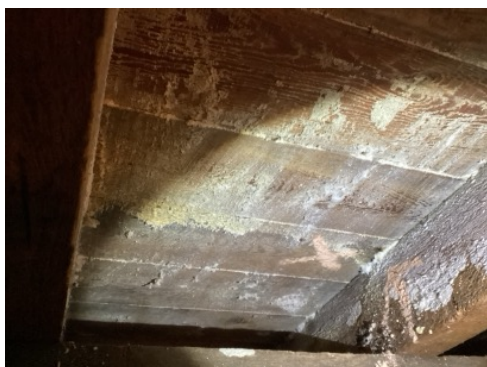
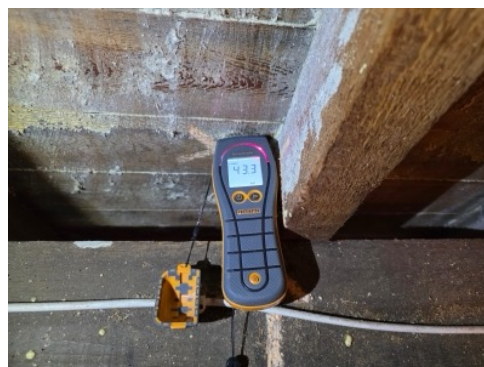
Timber X

43.3%

The area marked as X showed active water droplets around nail points, indicating moisture penetration. Moisture readings of about 43.3% exceeded the risk threshold for timber deterioration. No immediate damage was found, but minor water droplets suggest ongoing moisture ingress.

Area to be monitored.

These spots should be monitored to see if moisture levels stabilise or rise. If levels stay high or worsen, further inspection of the roof covering or fixings is needed to prevent decay or corrosion.

5. Monitor the areas marked X, where active water droplets were observed around nail points and readings of 43.3% moisture were recorded. If water ingress continues or elevated moisture levels persist, further investigation into possible defects in the roof covering or nail penetrations will be required.
